NASA-TM-X-2823C-1

EVALUATION OF REUSABLE SURFACE INSULATION
FOR SPACE SHUTTLE OVER A RANGE OF HEAT-TRANSFER RATE
AND SURFACE TEMPERATURE

By Andrew J. Chapman
Langley Research Center

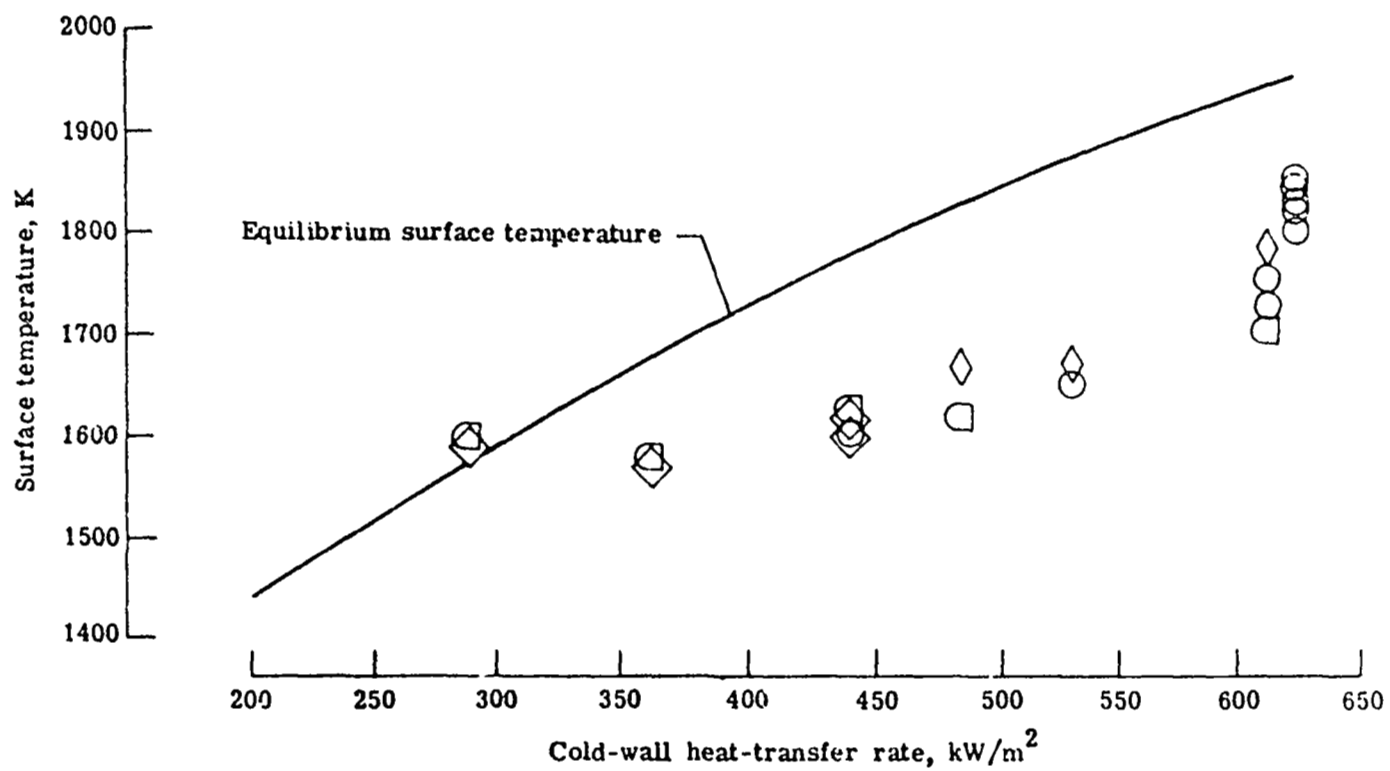
(a) Material S.

Surface temperatures for material S are shown in figure 7(a). At a heat-transfer rate of 300 kW/m^2 the measured surface temperatures were approximately equal to the calculated temperatures. At heat-transfer rates greater than 300 kW/m^2 , the measured surface temperatures are lower than the calculated values and follow a consistent trend except for data at a heating rate of 620 kW/m^2 where the temperatures measured on specimen S-3 (circles) increased with repeated testing, possibly as a result of decreased emittance.

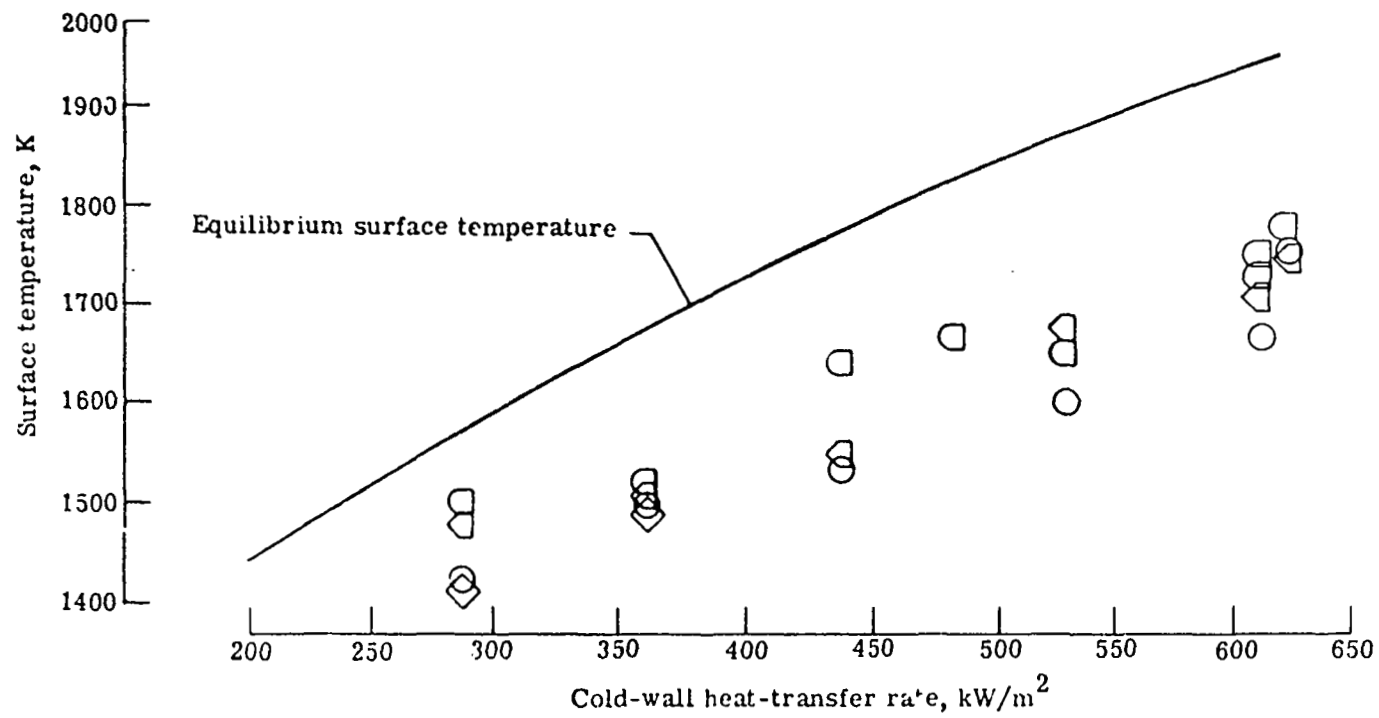
(b) Material MA.

Surface temperatures for material MA are shown in figure 7(b). The measured temperatures fall in a band well below the computed values and are generally somewhat less than the temperatures measured on material S.

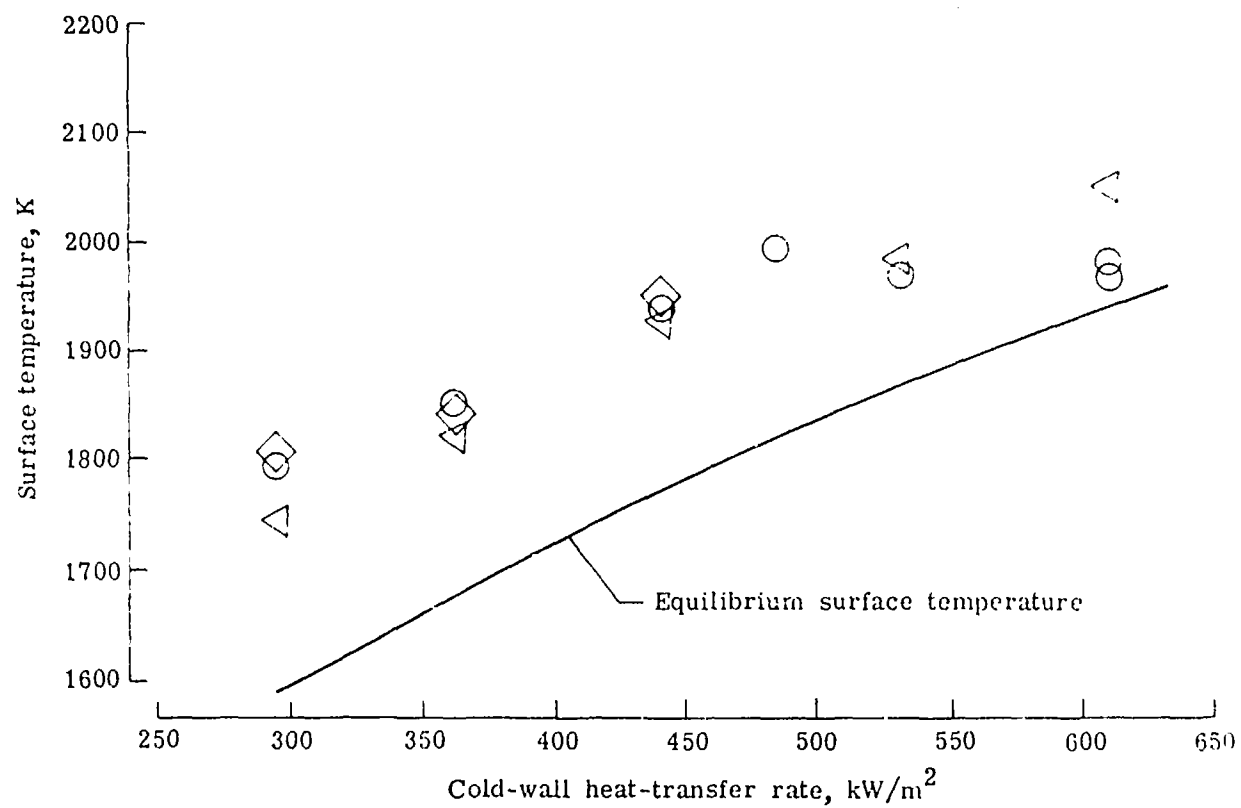
(c) Material MB.

Surface temperatures over the range of heat-transfer rate for material MB are shown in figure 7(c). Surface temperatures measured on this material throughout the range of test conditions were markedly higher than the temperatures measured on either material S or material MA. The trend of these temperatures, which is considerably higher than that calculated for equilibrium surface temperatures except at the highest heating rate, suggests that the surface is catalytic and that the actual emittance is less than the assumed value of 0.7. The untested surface of material MB is originally less glassy in appearance than that of material S or material MA.
